Restoration Advisory Board (RAB) Meeting

Former Naval Station Roosevelt Roads
Ceiba, Puerto Rico

October 25, 2007

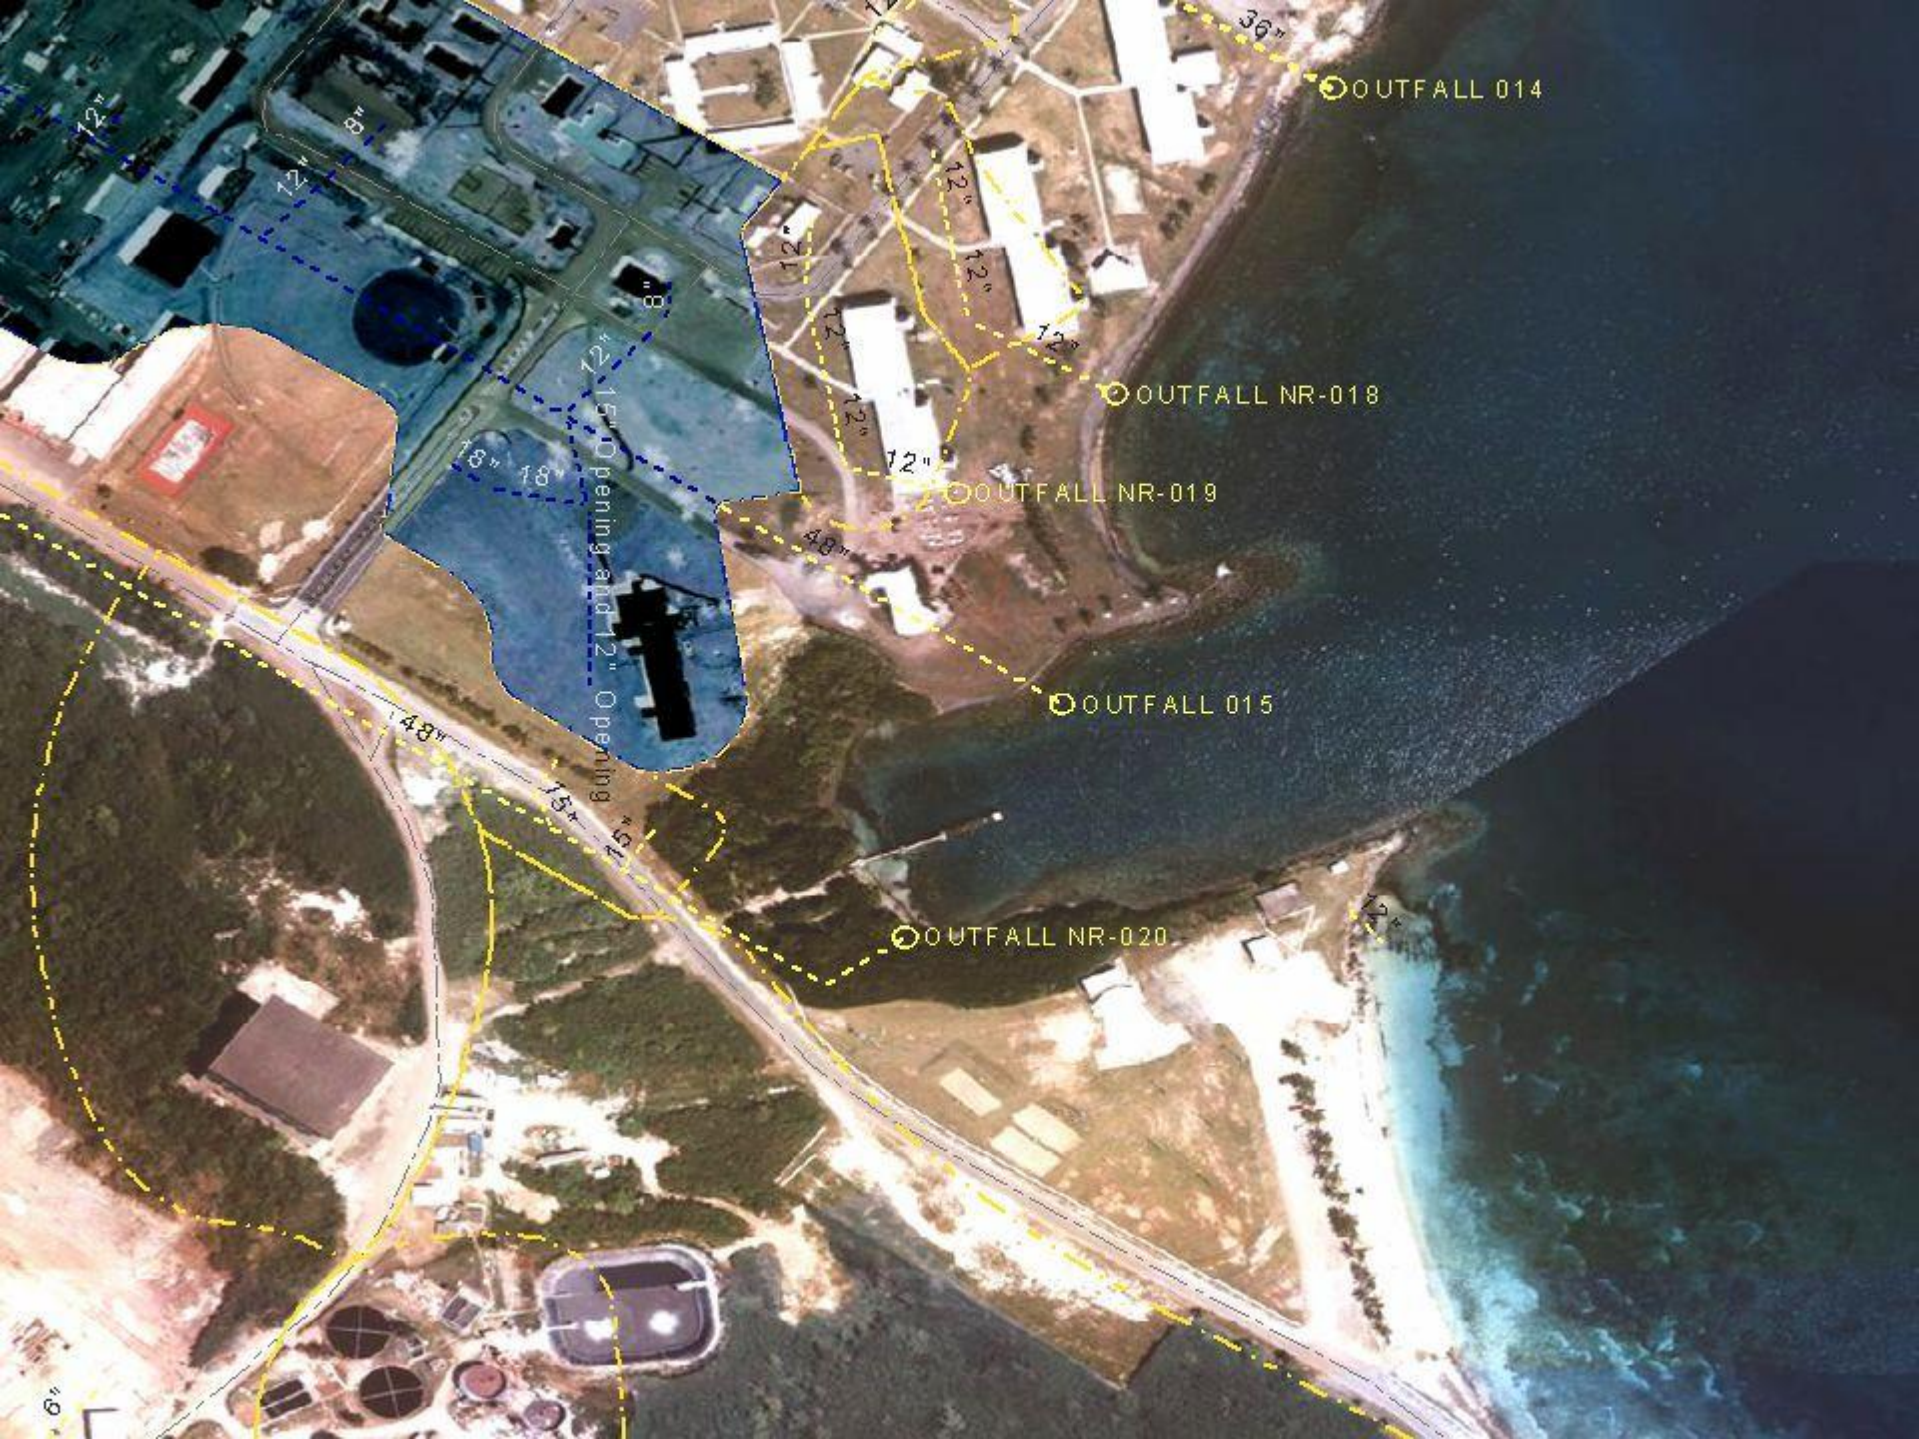
OUTFALL 015

- **Utilities at NAPR have been investigated/evaluated during their lifetime.**
 - Phase I and Phase II Inflow/Infiltration Study of the Basewide Sanitary Sewer System
 - *Corrective measures including pipeline replacement, manhole repairs, etc... were performed as a result of this study.*
 - Monitoring of regulated stormwater outfalls
 - *Attached image shows drainage boundary associated with regulated Outfall 015.*

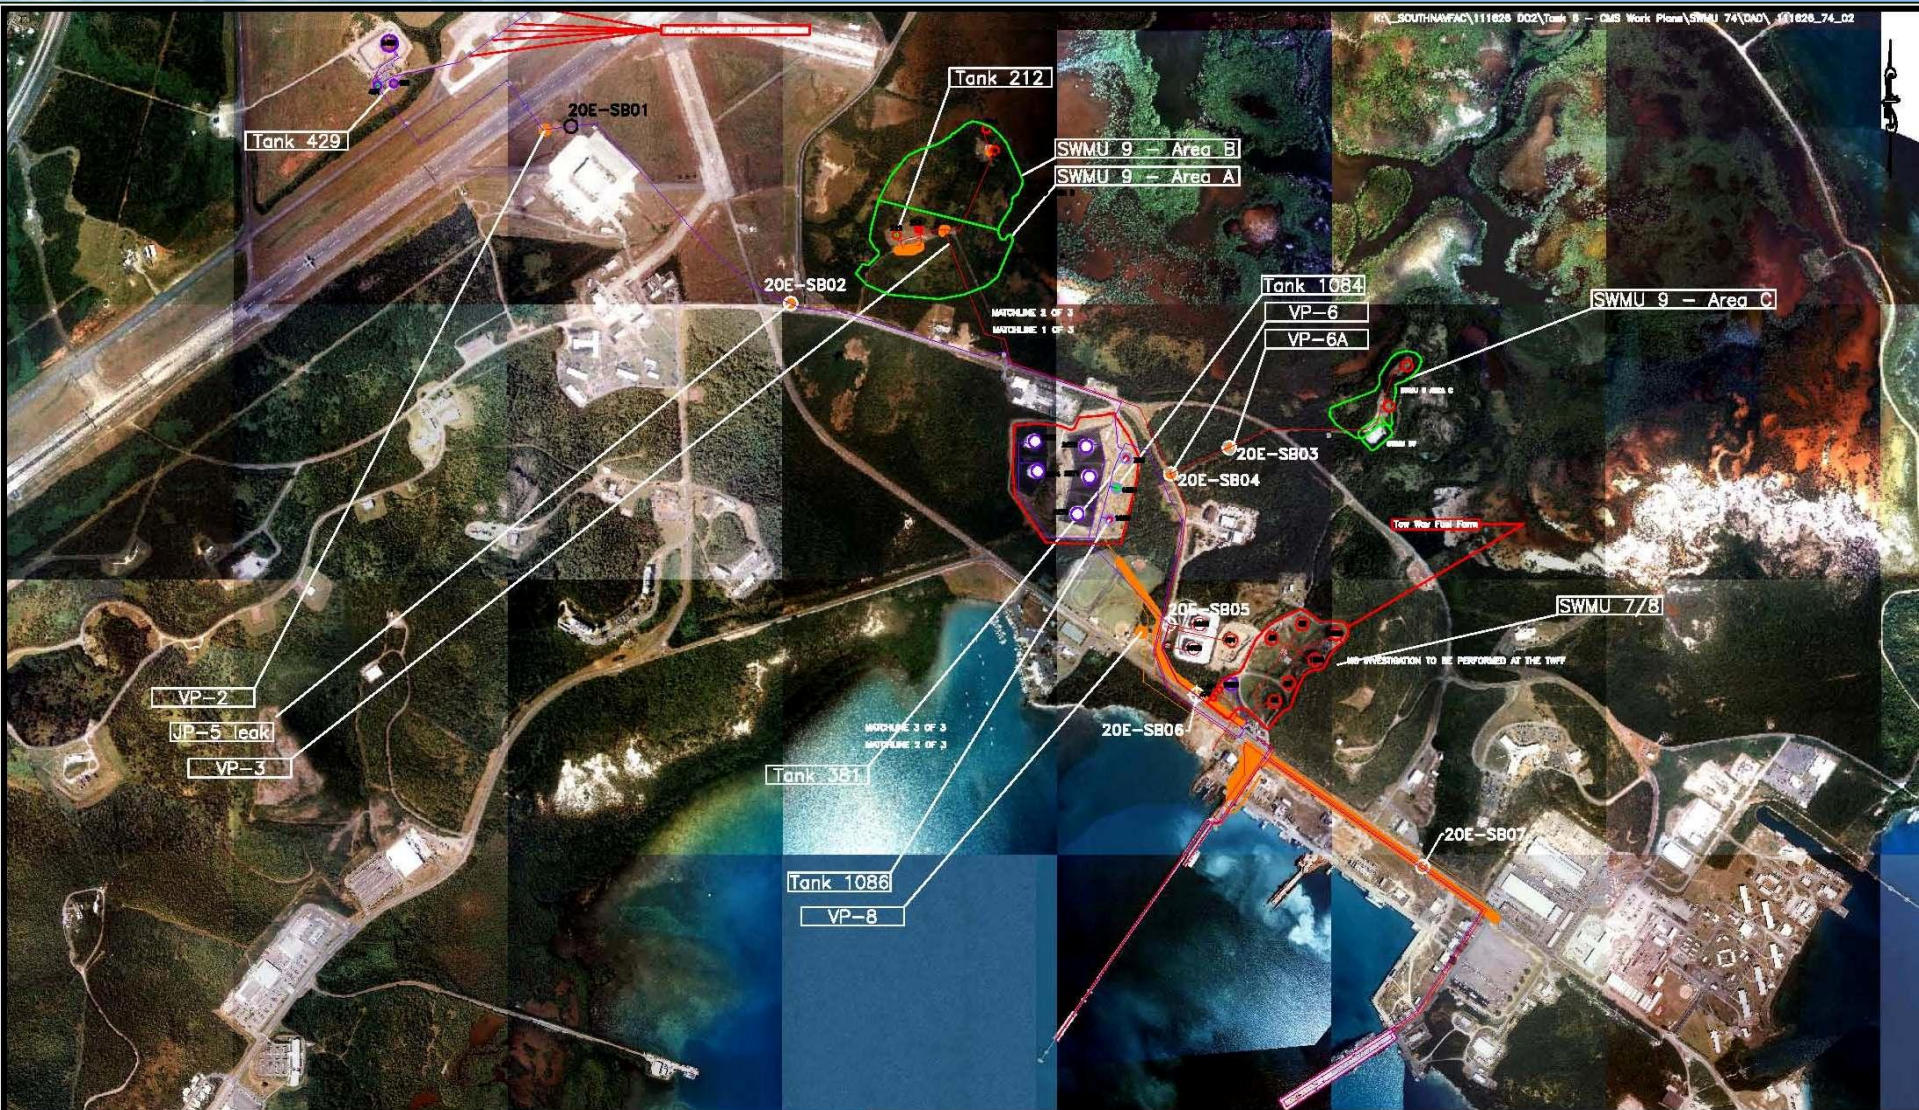
FIGURE 1-3
ECP SAMPLE LOCATION MAP
SWMU 74-FUEL PIPELINES AND
HYDRANT PITS
CMS WORK PLAN
NAVAL ACTIVITY PUERTO RICO

- **A CMS Investigation is proposed for the fuel lines, hydrants, and valve pits at NAPR (next slide).**
- **Phase I CMS Investigation:**
 - Investigate approximately 40,000 feet of pipeline, sampling every 100 ft for approximately 400 soil borings
 - Sample another 54 soil borings at the 27 valve pit locations
 - Sample groundwater at areas of suspected contamination and approximately one out of every 10 soil boring locations
- **Phase II CMS Investigation:**
 - Delineate any contamination identified during Phase I

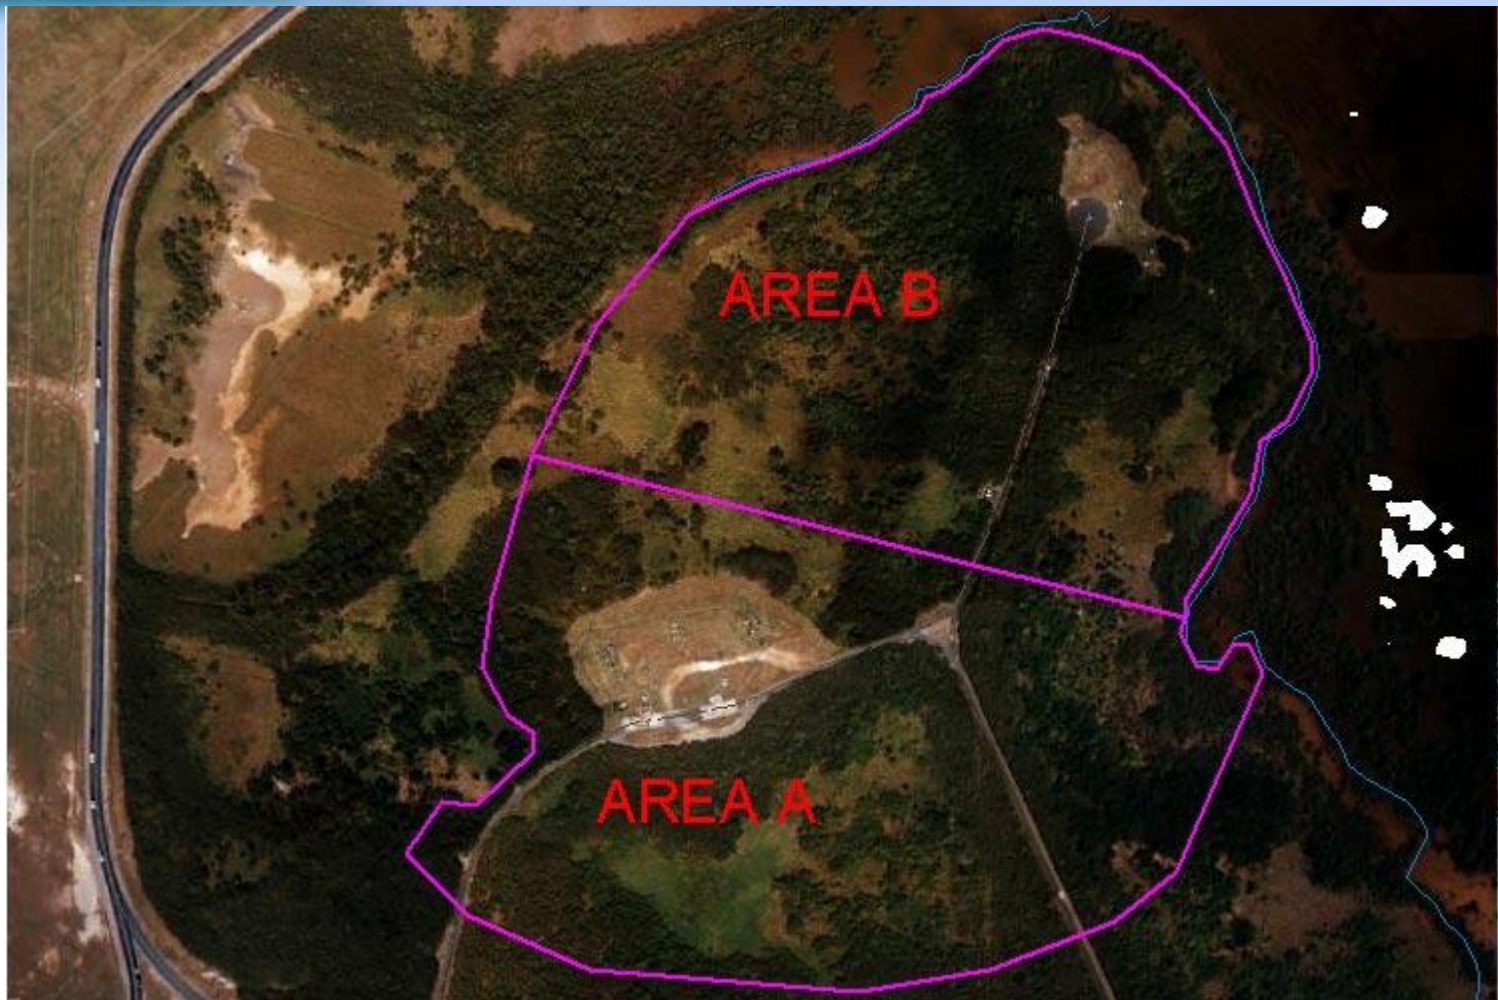
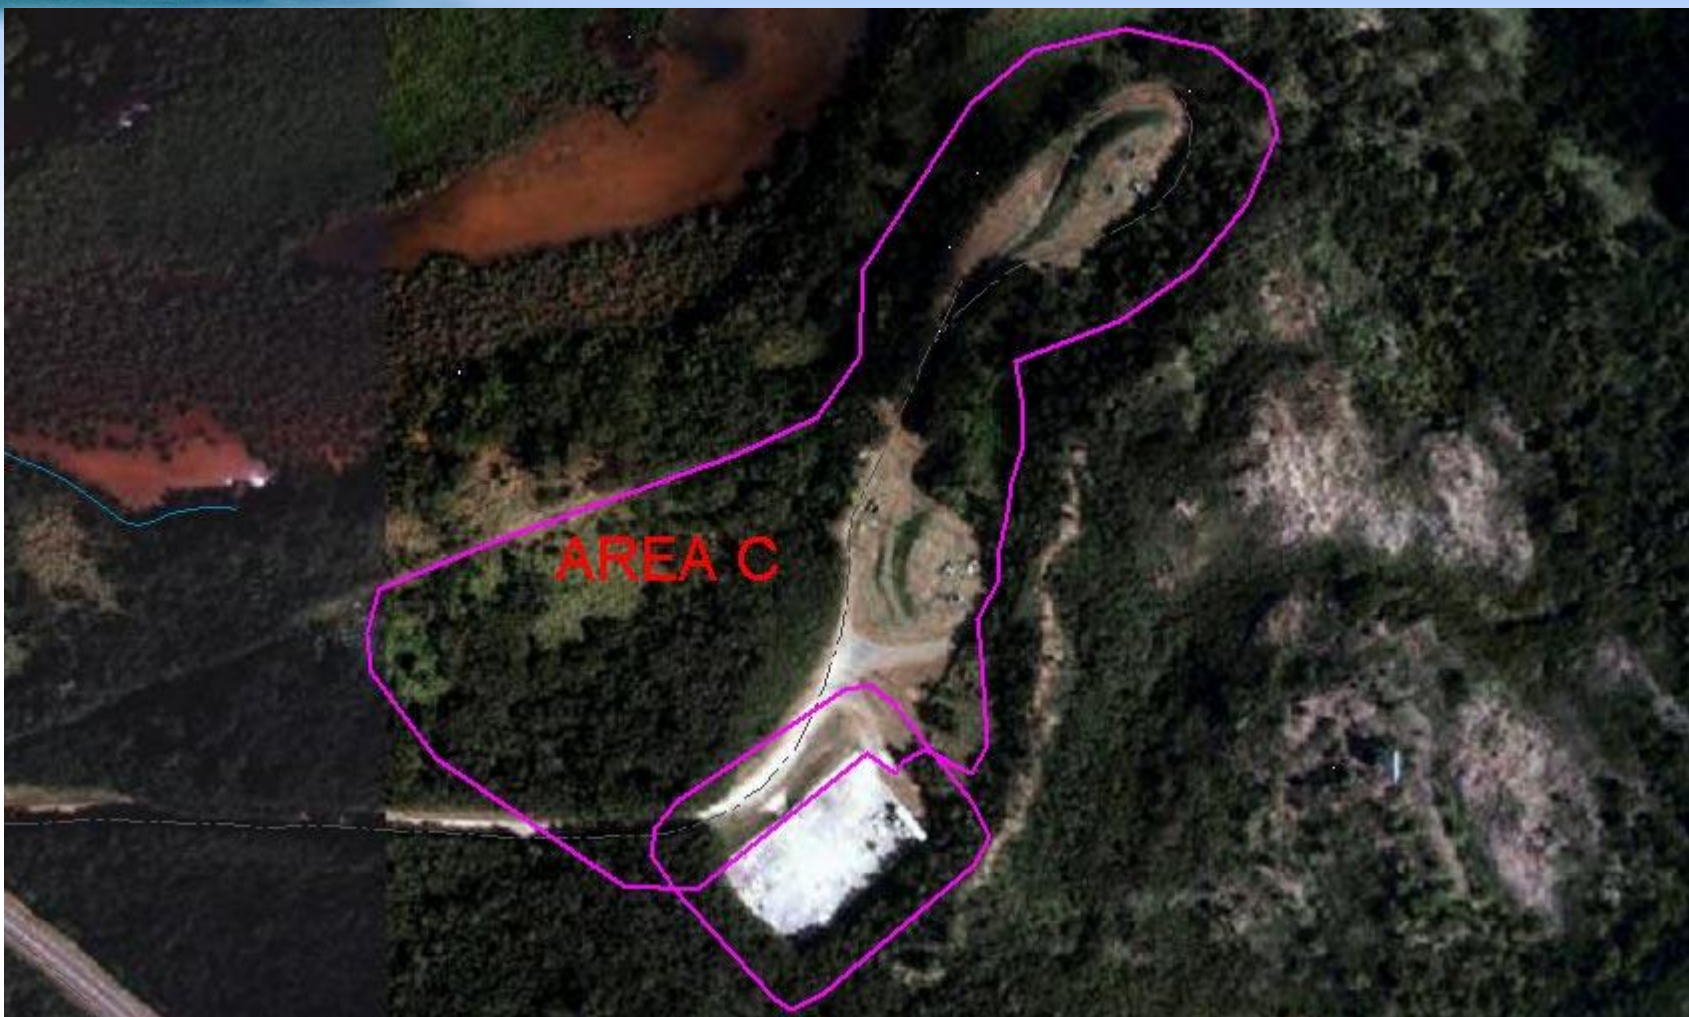
- Recommended for a full RCRA Facility Investigation (RFI) -1994
- Cut-and-cover storage tanks were constructed in the 1940s for fuel storage
- Six tanks and pipelines with support facilities were constructed in three areas: Area A, Area B, and Area C

- Prior to 1978, sludge from tank cleaning was disposed of in unlined earthen pits adjacent to the tanks.
- All tanks were cleaned and taken out of service in 2005.

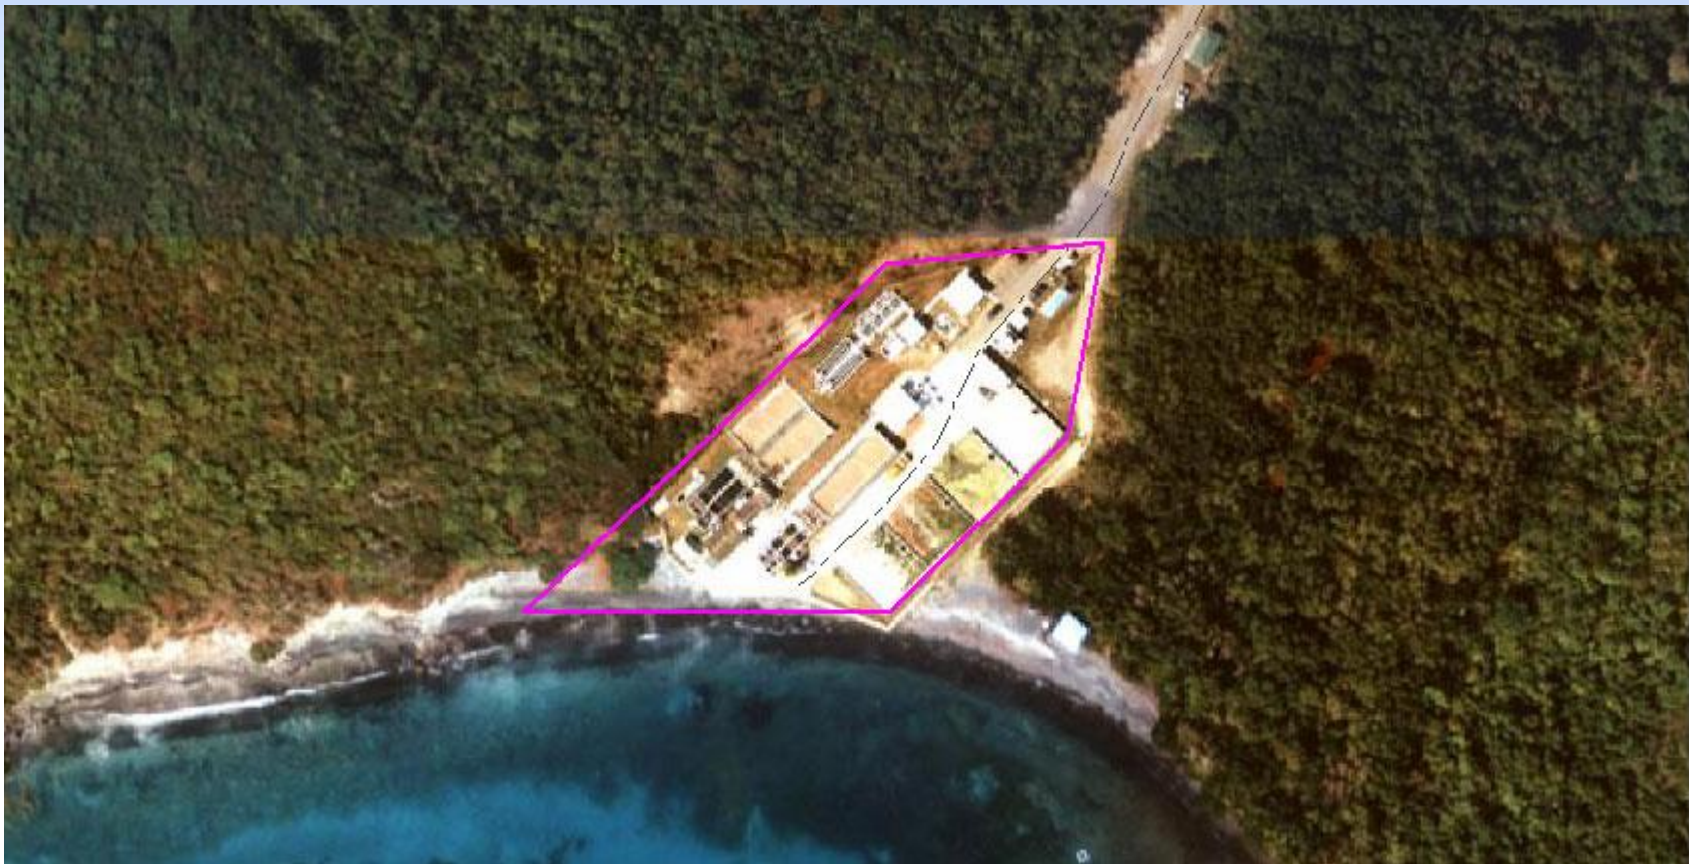
- SWMU 27 is the Sludge Drying Beds at Capehart Sewage Treatment Plant, which treats domestic sewage.
- The sludge is not considered to be hazardous.
- SWMU 27 was identified in the RCRA 7003 Administrative Order on Consent as a site requiring an RFI.
- Phase I RFI was conducted on soil and groundwater in 2006.

- Surface soil sampling at six locations, and subsurface soil sampling collected at one depth from three borings adjacent to the sludge drying beds.
- Installation of three temporary monitoring wells at the three borings and groundwater sampling.
- Arsenic and zinc in surface soil and arsenic in subsurface soil exceeded human health screening levels.
- Barium was found in the groundwater downgradient of the sludge drying beds, adjacent to ocean water.
- The Phase I RFI Report (April 2007) recommended a full RFI. Groundwater was not recommended because of the low yield of the aquifer.

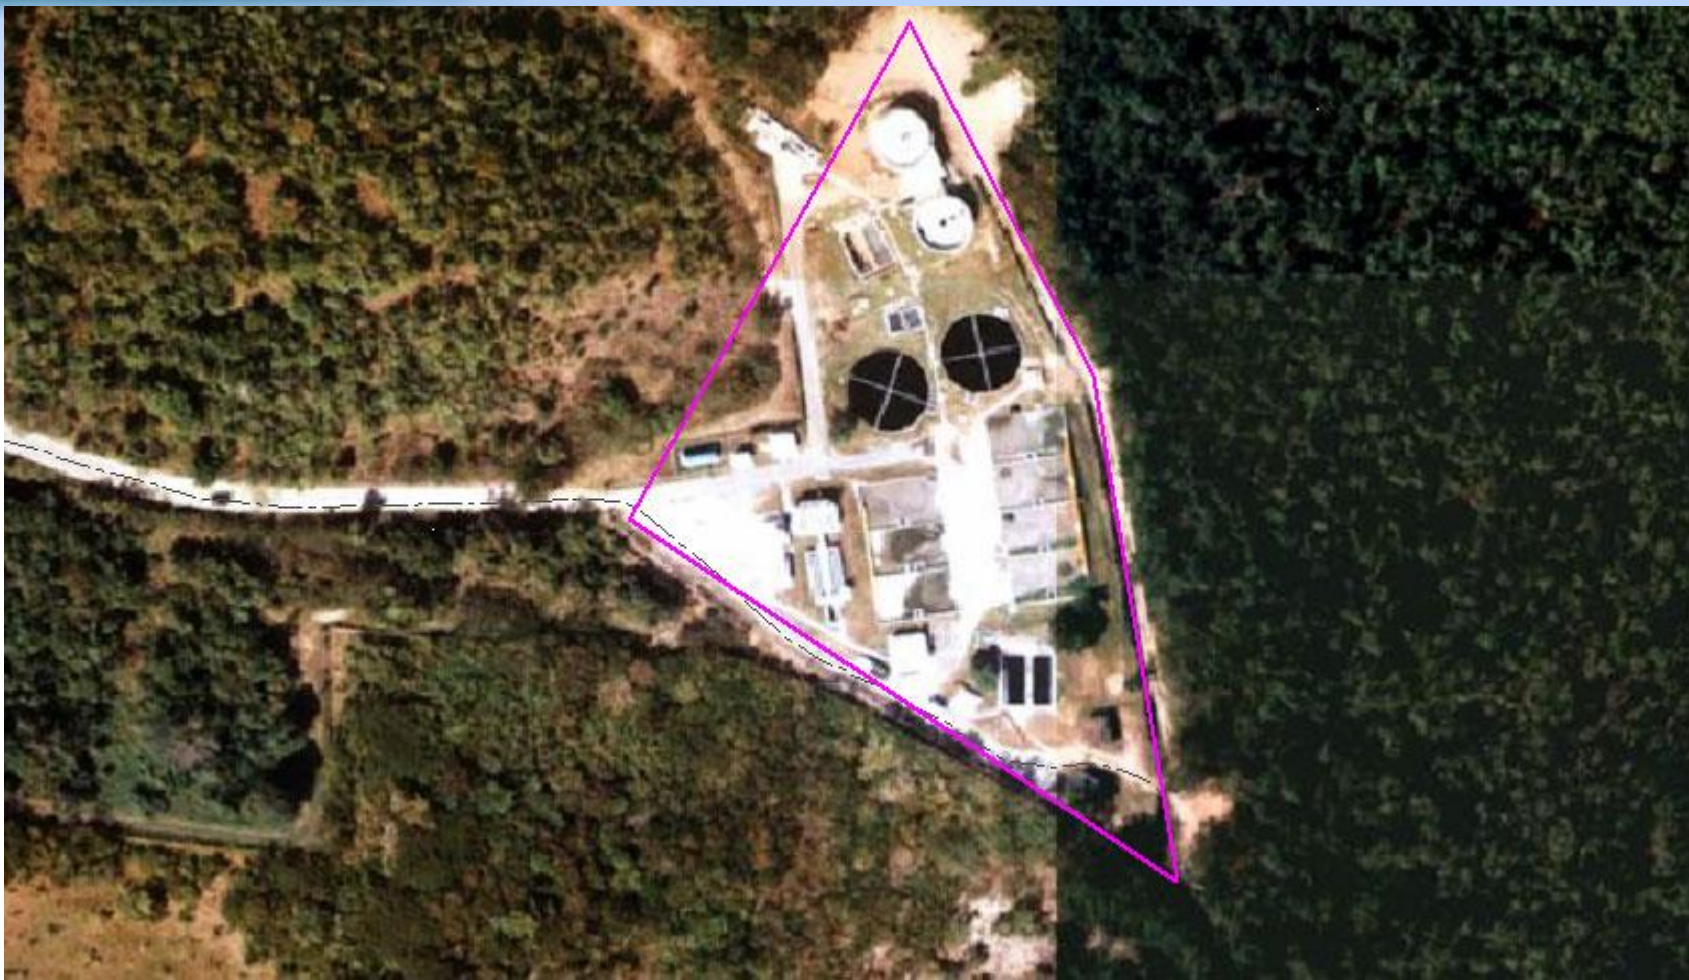
- SWMU 28 is the Sludge Drying Beds at the Bundy Wastewater Treatment Plant, which treats domestic sewage .
- The sludge is not considered to be hazardous.
- SWMU 28 was identified in the RCRA 7003 Administrative Order on Consent (January 2007) as a site requiring an RFI.
- Phase I RFI was conducted on soil and groundwater in 2006.

- Surface soil sampling at nine locations adjacent to the sludge drying beds; subsurface soil sampling at four locations in the eastern and southern portions.
- The installation of three temporary monitoring wells at three boring locations, and groundwater sampling.
- A PCB compound (Aroclor 1260) was detected in the surface soil at four of the nine locations, it exceeded its human health screening value at one location only.
- Several inorganic compounds exceeded human health and ecological screening values, as well as their background concentrations in both the surface soil and groundwater media.
- The Phase I RFI report (March 2007) recommended a Full RFI Investigation in order to delineate the site contamination above background levels in both surface soil and groundwater, as well as evaluate the potential for human health and ecological risk.

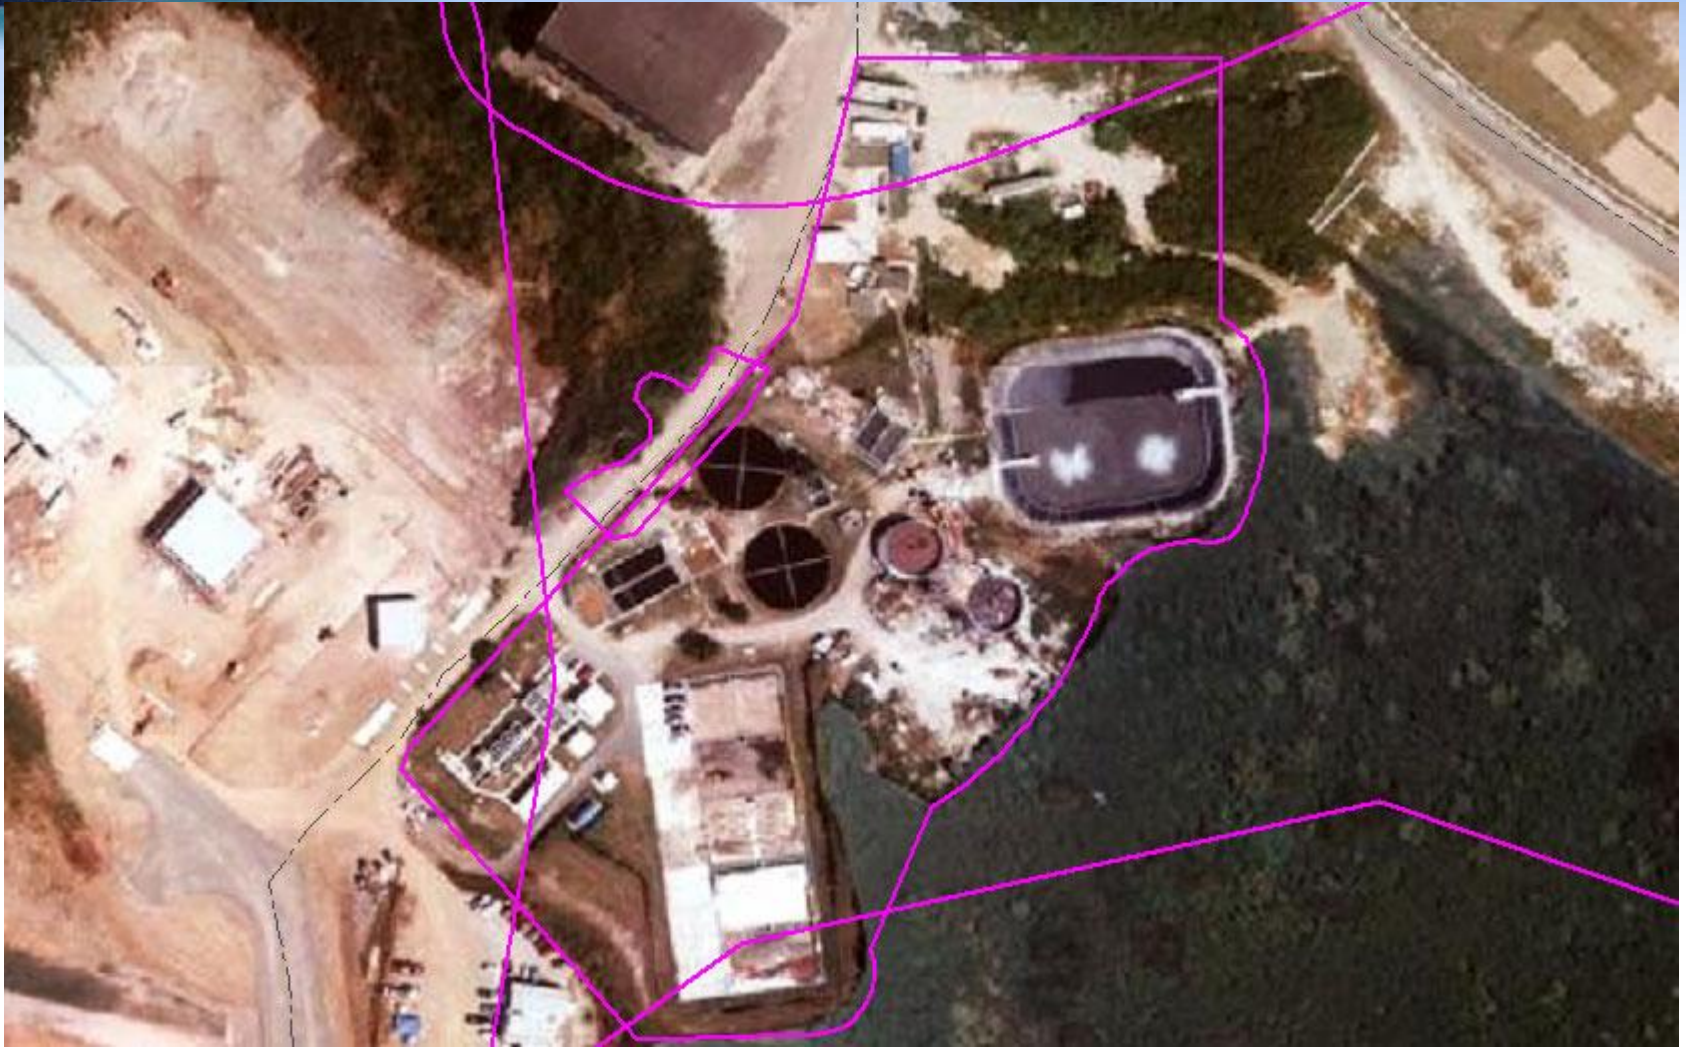
- SWMU 29 is the Sludge Drying Beds at the Industrial Area Wastewater Treatment Plant, which has been in operation since 1963.
- The sludge was tested and found to be non-hazardous.
- SWMU 29 was identified in the RCRA 7003 Administrative Consent Order (January 2007) as a site requiring an RFI.
- A Phase I RFI was conducted on soil and groundwater in 2006.

- Surface soil sampling at eight locations adjacent to the sludge drying beds; and subsurface soil sampling at six locations.
- The installation of four temporary monitoring wells in four of the six soil borings and groundwater sampling.
- Several metals exceeded screening criteria and background levels on the eastern/western sides of the drying beds.
- The subsurface soil did not exhibit any exceedances of the human health or ecological screening criteria.
- No significant contamination was found in the groundwater at the site.
- The Phase I RFI report (April 2007) recommended a Full RFI Investigation. No investigation of groundwater was recommended based on the findings.

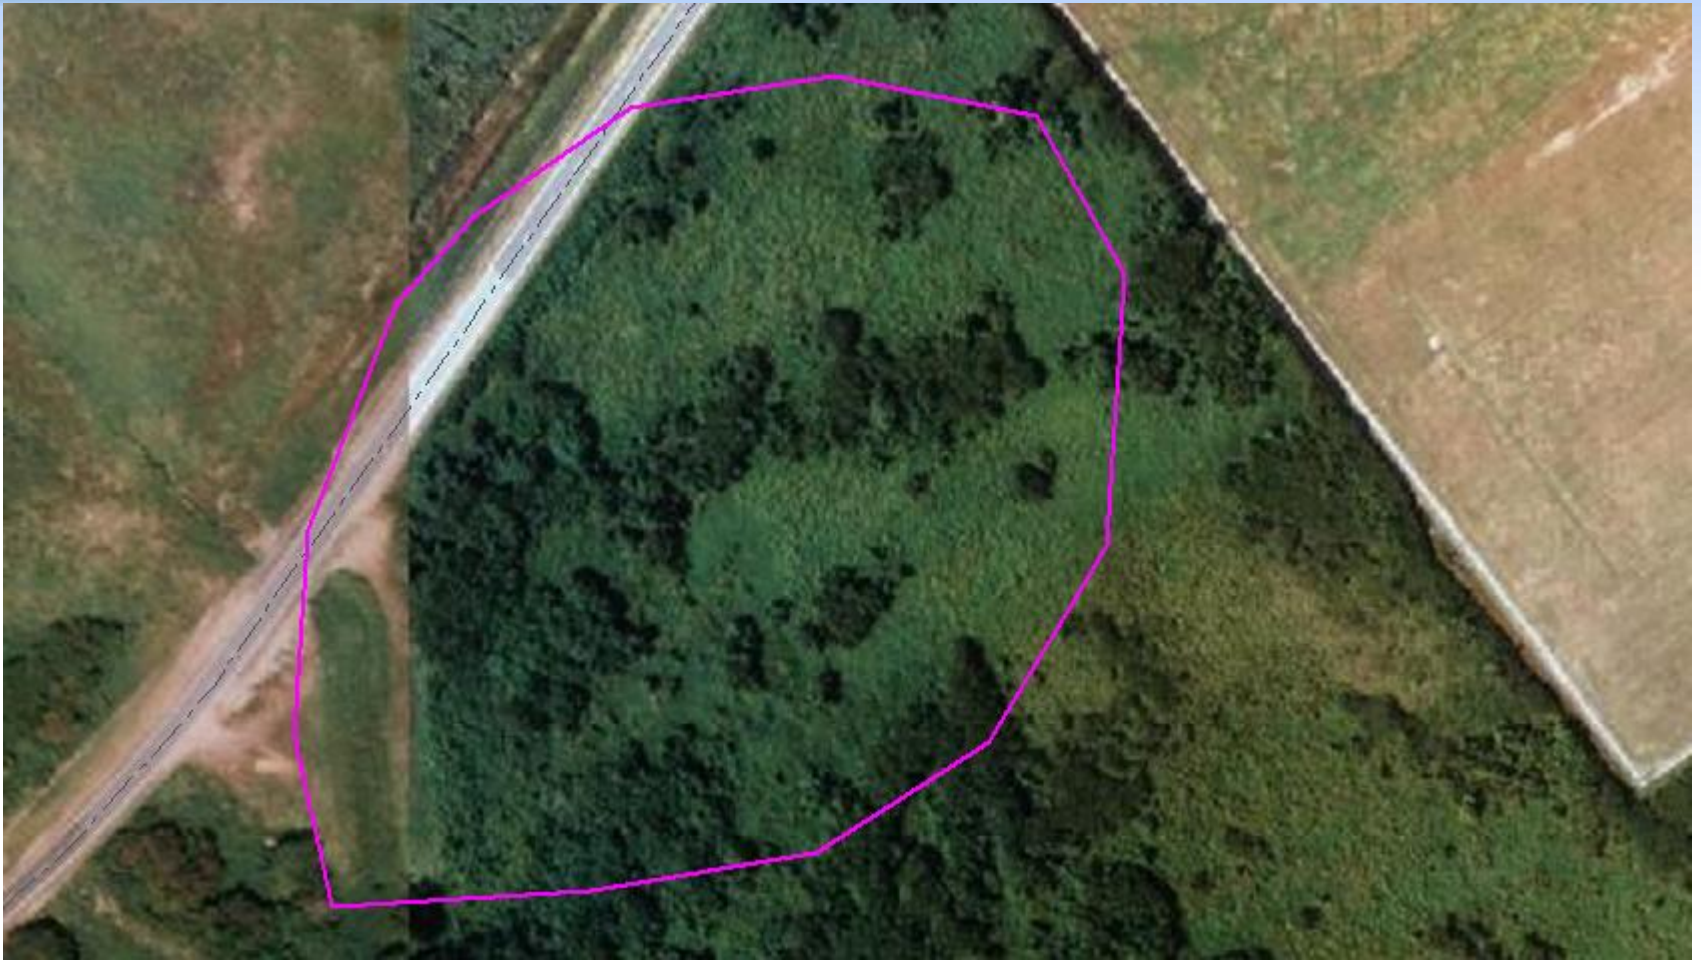
- SWMU 68 is an open area southwest of the Ofstie Airfield.
- Fire training was conducted during the '50s and '60s.
- Aerial photos showed the area that was disturbed during the fire training.
- SWMU 68 was recognized in the RCRA 7003 Administrative Order (January 2007) as a site that required an RFI.

- An Environmental Condition of Property investigation by the Navy in 2004 showed metal- and fuel-related (diesel) contamination in soil.
- A Phase I RFI (reported in March 2007) confirmed metal contamination in soil. A removal of lead- contaminated soil is recommended to address ecological concerns.
- Phase I RFI did not find significant arsenic contamination in soil; however, based on USEPA's comments (July 20, 2007), additional surface soil investigation was recommended to ensure delineation of arsenic in the surface soils.
- Additional surface soil samples were collected for analysis of arsenic in September 2007. Laboratory analysis is ongoing. Phase I RFI Report will be revised to include the results from this additional sampling.
